REPORT OF MARINE SURVEY

PRE-PURCHASE CONDITION & VALUE of the vessel

**"Survey 1"
xxxx, Sample Sail**

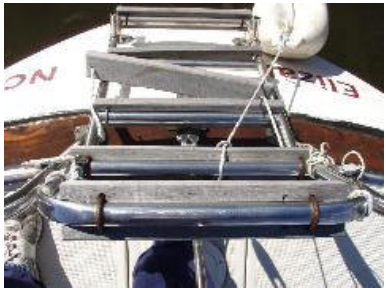
Swim/Boarding ladder: The boarding ladder is stainless steel that is mounted on transom. The ladder rungs have teak steps secured with rusty u-bolts. **One step is missing u-bolt and partly adrift.**

One step is missing u-bolt and partly adrift.

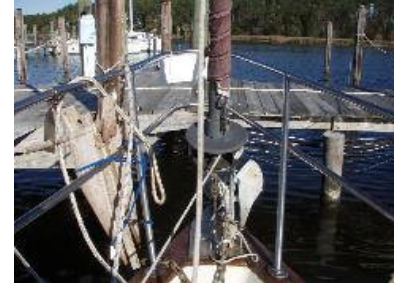
- Anchor platform:** Stainless steel with anchor roller. Well secured-no cracks sighted.
- Anchor/chain locker:** Yes accessed from top deck. Hatch lock is partly adrift and does not function. Stem drains are clogged.
- Toe rail(s):** Teak toe rails are in need of cleaning and protection from elements.
- Scuppers/deck drain(s):** Hoses where sighted are secure. Some of the drains are partly clogged with debris and should be cleared..
- Bow pulpit/rail:** Stainless steel Bow pulpit is secure, however slightly askew toward port side indicating previous impact.

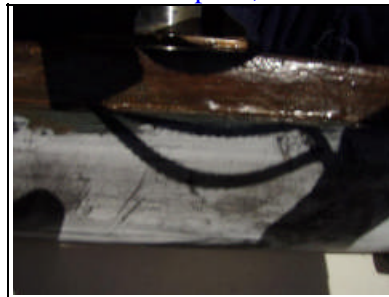
- Stanchions/side rail(s):** Stainless steel and well secured. One stanchion on port side (#3 counted from forward) is slightly bent and distorted at base plate. Recommend removal in order to fair out base plate, stanchion and re-bed.

One stanchion on port side (#3 counted from forward) is slightly bent and distorted at base plate. Recommend removal in order to fair out base plate, stanchion and re-bed.

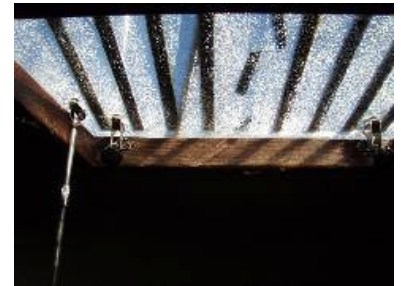
- Escape hatch(es):** Forward main cabin top escape hatch has crazed glass and broken support arm. The gasket is broken and partly adrift with evidence of leaking inside. RECOMMENDATION: Repair or replace as necessary.

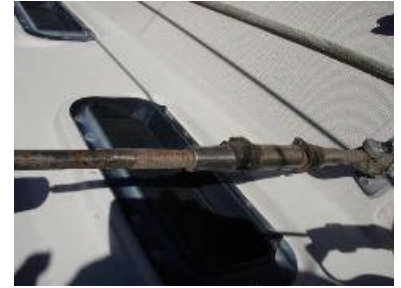
Material & Condition: Stainless steel wire and connections. Some corrosion (rust) sighted. **RECOMMENDATION:** Corrosion could indicate a weakened condition of stay, swage fittings and turnbuckles. Considering vessel's age, detailed inspection by qualified rigger is recommended and replacement as deemed necessary.

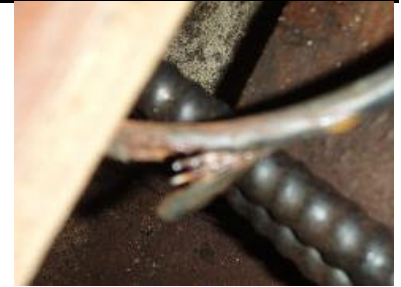
Throttle and shift controls:	Separate levers for each engine throttle and shift control. Shift control cable cover is breached; cable should be renewed.
-------------------------------------	---

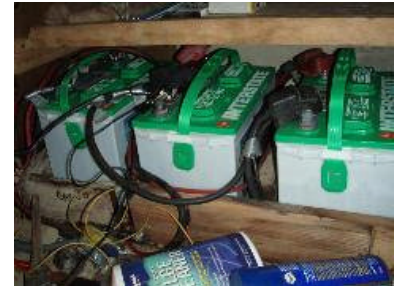
Battery selector switch:	Yes Rotary switch is functional. NOTE: Recommend alternating use of battery one and two when using vessel. Only use the battery switch All position if both batteries are low or when charging with battery charger/alternator.
Charging system:	Engine mounted alternator plus the battery charger.
Distribution panel:	Yes located at navigation station.
Breaker(s)/fuse(s):	D.C. circuits are protected by branch or switched breakers.
D.C. usage meter(s):	Analog type, Volts.
D.C. wiring:	All wiring runs sighted are properly secured.
DC Electrical ground:	DC electrical system is properly tied into vessels electrical ground system using the engine as a common ground.

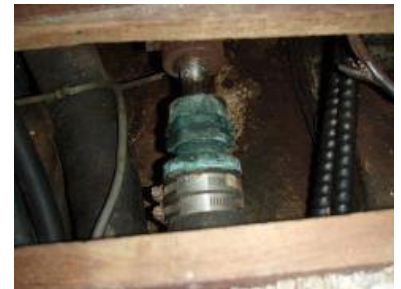
Propeller shaft(s): 1", Stainless steel.
Stuffing box(es): Stuffing box and packing gland, bronze hex nut type, is corded but remains serviceable. Maintenance access from aft cabin.

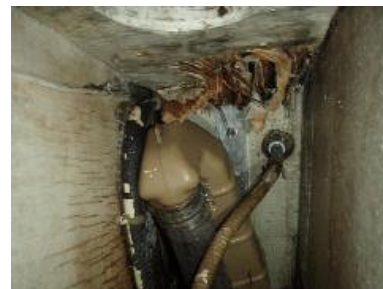
Damage sighted: Surveyor noted that a 1 inch thick top plywood panel over the rudder stock space is rotted through and wet. The exhaust hose situated below this area is also affected. The source of water is most likely around the deck access port for the emergency tiller. Recommendation: Re-bed the access port to prevent further ingress of water. Repair / replace damaged plywood, which is integral to the construction of the deck storage boxes.

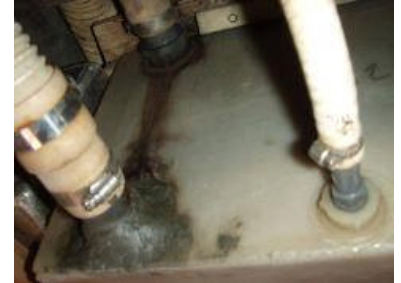
No & Location of tanks: One holding tank located under aft berth area.
Tank(s) type & capacity: Plastic with a total capacity of reportedly 60 gallons. **No marking are on the tank to verify capacity.**
Tank(s) secured: Yes.
Tank(s) condition: Evidence of tank leakage noted at inlet connection, and some waste water in nearby bilge area resulting in malodorous condition. **RECOMMENDATION:** Remove tank, clean area and repair or replace tank or fittings as necessary.

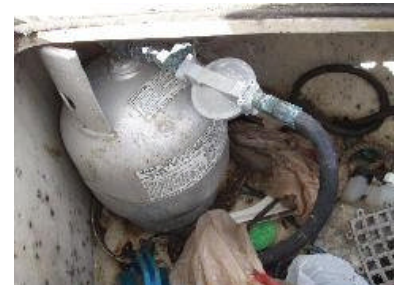
No & location of tanks: One tank.
Secured: Tank is not properly secured to prevent upset or displacement that could place a strain on fuel distribution or appliance fittings. **RECOMMENDATION:** Secure tank and hose as necessary per ABYC A-1 recommendations.

Tank is not properly secured to prevent upset or displacement that could place a strain on fuel distribution or appliance fittings. RECOMMENDATION: Secure tank and hose as necessary per ABYC A-1 recommendations.

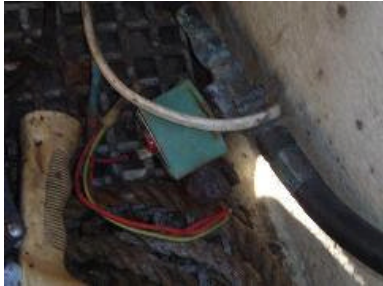
Shut off valve(s): LPG shut off valve at the tank top is functional. Solenoid shut off switch is rusty and not functional. Recommend installing new unit in compliance with current ABYC A-1 recommendations.

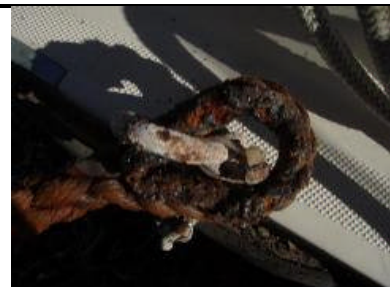
Primary anchor: Secured to anchor platform. The anchor line thimble is heavily corroded and likely to fail. Recommend replacement.

The anchor line thimble is heavily corroded and likely to fail. Recommend replacement.
